## ENGINEERING ANALYSIS OF STRUCTURES AND ASSESSMENT OF THE TECHNICAL CONDITION OF ARCHITECTURAL MONUMENTS

*This article provides an assessment of the technical condition of the Kok Gumbaz mosque located in the city of Shakhrisabz based on instrumental checks and visual observations. Suggestions and recommendations for the elimination of certain defects, damages and deformations are given.*

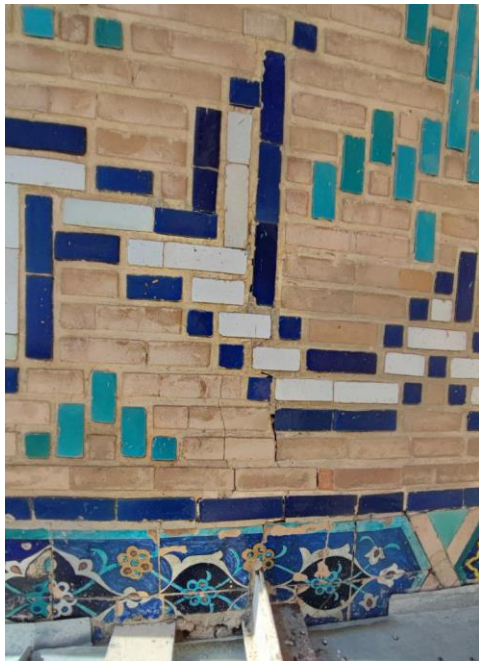
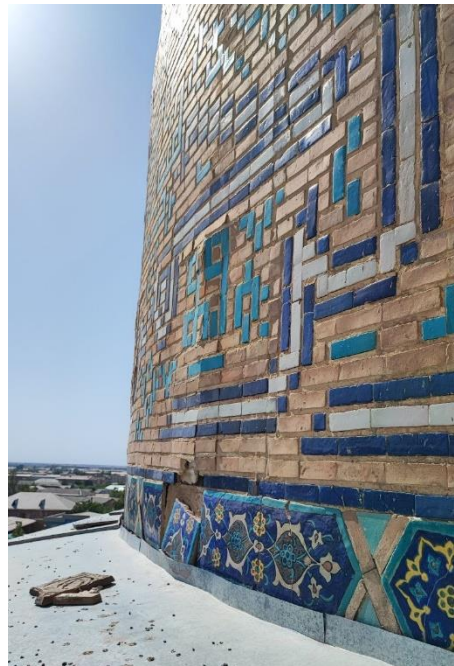
*2 fig.*

The foundations of the mosque are brickwork on stucco mortar with dimensions of 250x250x50 mm and 300x150x50 mm. With high humidity, the foundation can be seriously jeopardized. Soil moisture increased by 37-48%. The foundations of the gallery parts are made at different heights and are located on the surface of construction debris. After a certain time, this circumstance can lead to trouble. The parts of the mosque erected in antiquity were destroyed under the influence of external forces. For several years, the foundations have been adapted to reduce the impact of a constant load. Not taking into account this circumstance, an additional load was added to the gallery of the monument during the reconstruction. When studying cracks, cracks and damages were found in the outer southern part of the drum (Fig. 2).

*Crack and deformation in the south outer side of the drum.*

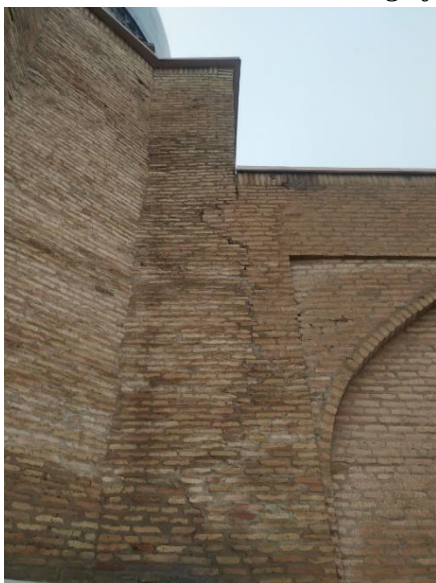
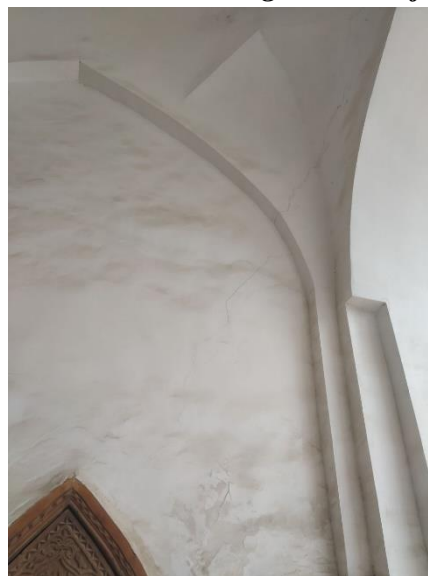
**3-fig.**

The mosque consists of two domes and no cracks were found during observations on the second floor, which means that these changes relate to cracks that appeared on the colored coating installed above the dome. There are 3-4 cracks on the surface of the southern wall. There are serious cracks in both balconies and they mainly appear from the shrinkage of the columns (3-fig.). Of the four parts of the mosque, pits were drilled and studied, on the basis of these studies it was found out that the foundations were built from various building materials over construction debris and at different heights.

***Cracks in the building of the mosque and between the galleries adjacent to it.***

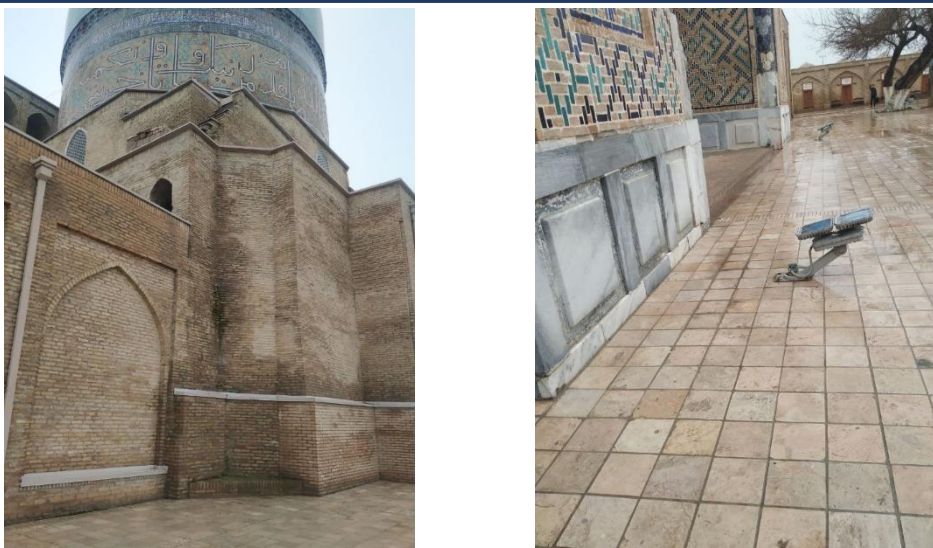
The territory of the mosque is completely concreted, as a result, the evaporation that appears from underground moisture changes its direction, rises between the walls of the mosque and the walls of the entire historical monument are completely moistened (Fig. 4).

**4-fig. Coverage on the territory of the mosque and its impact on the mosque**

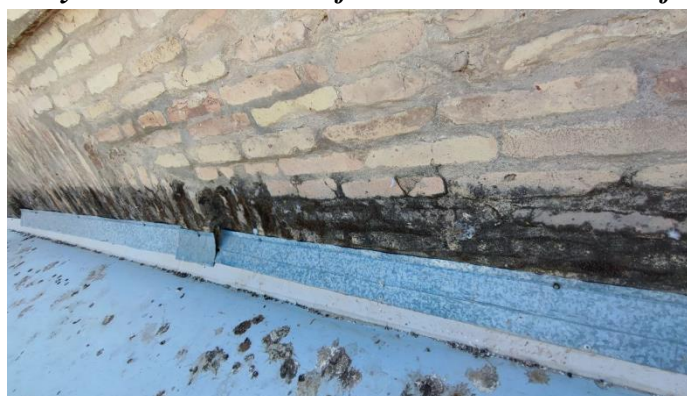
5-fig.

The back part of the arch of the historical monument, a certain part of the inner dome, as well as the octahedron are in a deplorable state, due to improper organization of wastewater drainage, for many years this water penetrated through the walls and managed to get moldy (Fig. 5). During the restoration work, the ventilation hatches intended for ventilation were closed, due to the lack of ventilation, the humidity had a serious impact on the brick and clay walls. Humidity on the walls had a negative impact on the finishing work of the interior of the mosque building and, as a result of damage in the exterior finishing parts, ceramic tiles were displaced from their original positions (Fig. 6).

*Mold caused by the accumulation of moisture on the walls of the mosque*

Tidy up the drainage system from surface runoff from the roof and surrounding area. Drains are recommended to be diverted outside area mosques.

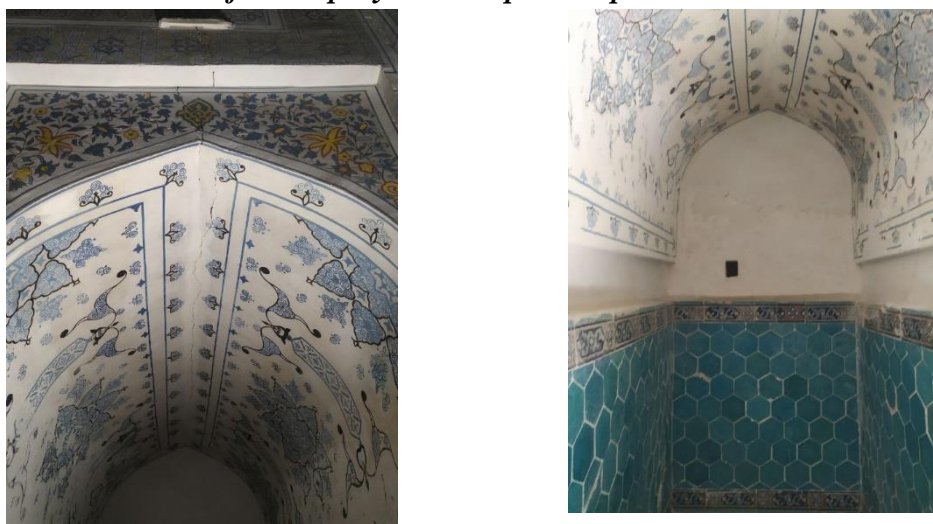
7-fig.

There are cracks along the entire length and from bottom to top on the arches (chillakhons) of the room for the solitude of a Muslim for the purpose of fervent prayers and spiritual practices, in the side part of the mosque wall niche, indicating the direction to Mecca (qibla) (Fig. 7).

*Cracks that appeared on the arches are a room for the solitude of a Muslim for the purpose of fervent prayers and spiritual practices*
