SOME FEATURES OF DAMAGE TO UN-CUT REINFORCED CONCRETE BRIDGES UNDER SEVERE EARTHQUAKES

Shermukhamedov U.Z.,¹ Tayirov Sh.Sh.²

Tashkent State Transport University

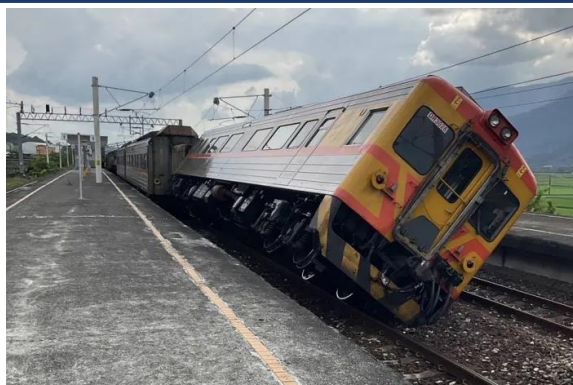
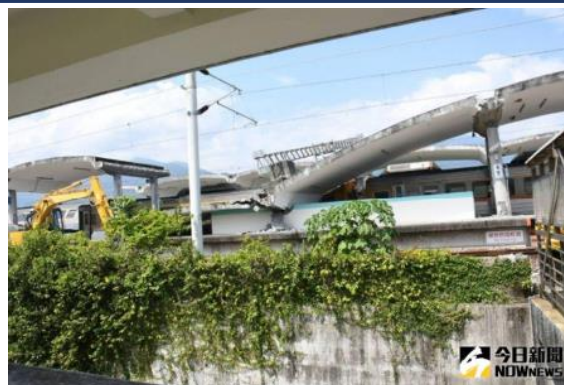
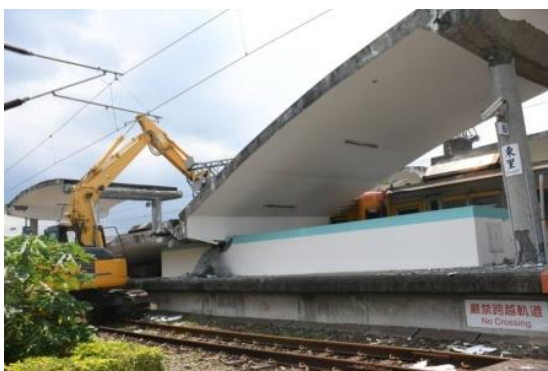
Fig. 3.

(a) Train derailment at Dongli station in Hualien. (b) - (c) Collapsed train platform roof at Dongli Station in Hualien County.

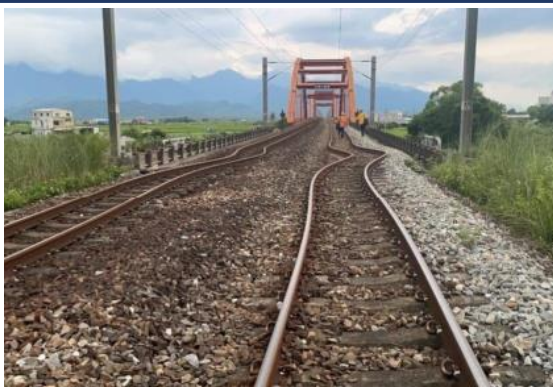
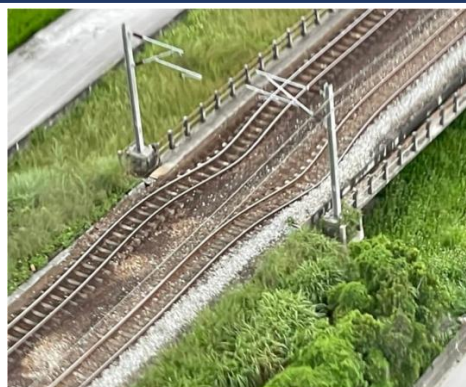
Fig. 4.

Severe damage and displacement of railway tracks after the 2022 Taiwan earthquake.

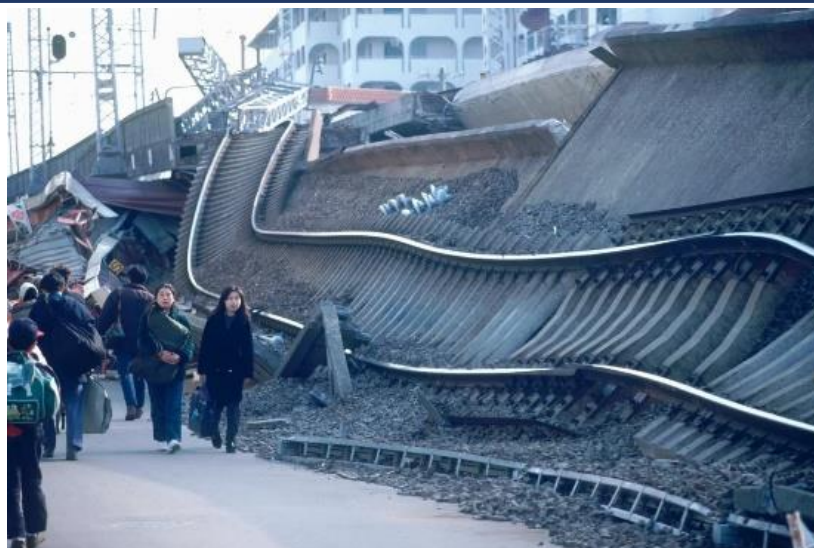
Fig. 5.

Devastating earthquake in Kobe (Japan) January 17, 1995

As is known, man-made structures such as bridges and overpasses are complex design solutions with many coupling elements. For example, in the longitudinal direction, spans can be continuous (monolithic), free or fixed to the structure. Thus, for the structure to be effectively strong, the connections at the top and bottom of the piers must be strong enough to operate in plastic hinge mode. If the bearings are poorly designed, then most of the damage occurs in those places, which leads to less reliable results. Most often, damage of this type occurs due to insufficient reinforcement at the joints. This occurs between decks and piers, as was observed during the 1995 Kobe earthquake (Figure 5), or between piers and foundations, as occurred during the San Fernando earthquake (Figure 6).

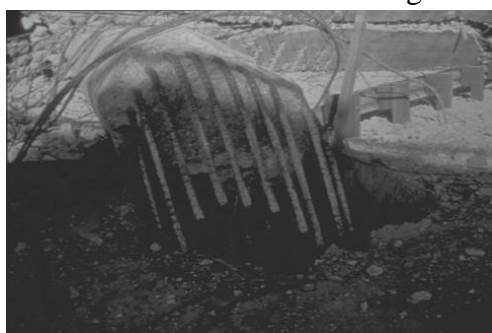
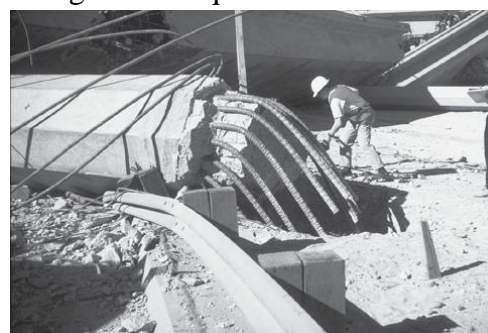
Fig. 6.

Overturning of the bridge during the earthquake in San Fernando, 1971

Another type of joint damage often observed after earthquakes is related to the lack of stiffness at the joints between the pier and the foundation. If a connection should transmit bending moments and shear forces between elements, then a large amount of reinforcement is required to prevent shear damage at the joints [6]. Figure 6 shows weak reinforcement of the piers located in pile clusters that contributed to the overturning of the bridge during the 1971 San Fernando earthquake.

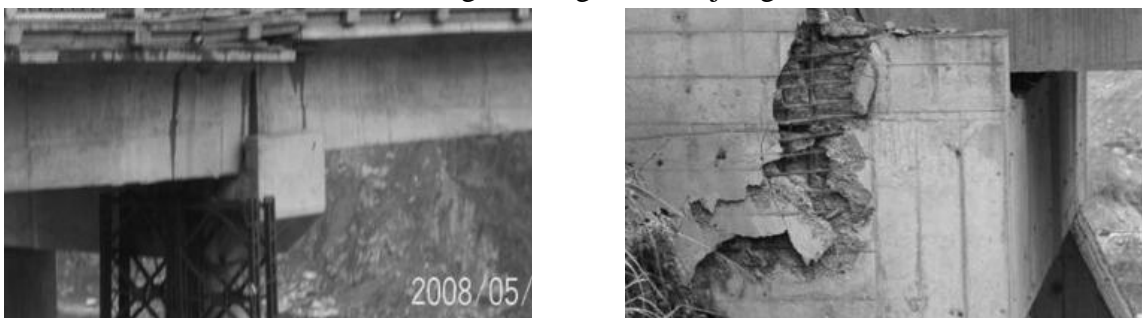
The Shoujiang Bridge (Fig. 7) suffered serious damage, such as the displacement of beams, sliding of the bearing parts, abutment shear failure, and subsidence of the bridge deck. The fifth span of the Baihua Bridge collapsed, and the others were badly damaged, making them unusable (Fig. 8). Fig. 7.

Bridge Damage in Shoujiang

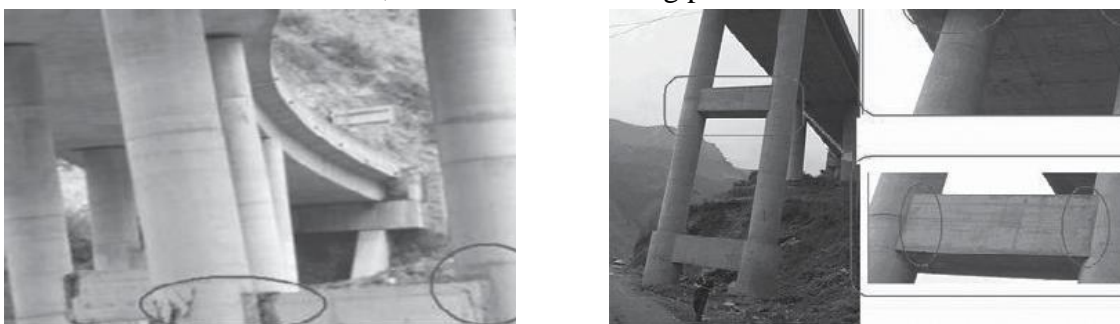
Fig. 8.

Baihua Bridge: (a) destruction of the connection of tier with a tie beam; (b) tie beam fracture, destruction of bearing parts

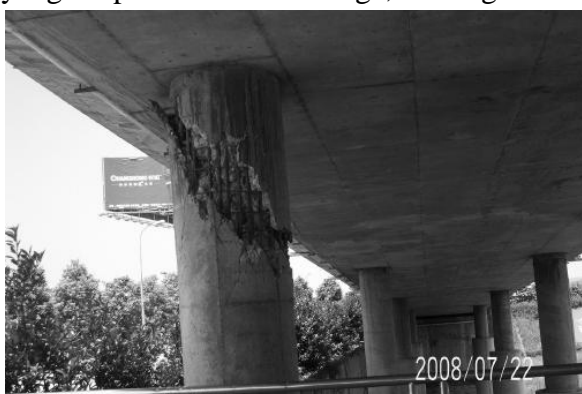
Fig. 9.

Mianyang Airport Terminal Bridge, bearing shear failure

In addition, local bridges in various cities in China were damaged to varying degrees. The piers of the Mianzhu Huilan overpass collapsed under shear, one span of the Gaoyuan Bridge in Dujiangyan city collapsed; The Mianyang Airport Terminal Bridge sustained damage such as shear failure of supports (Fig. 9) and displacements of the superstructure.

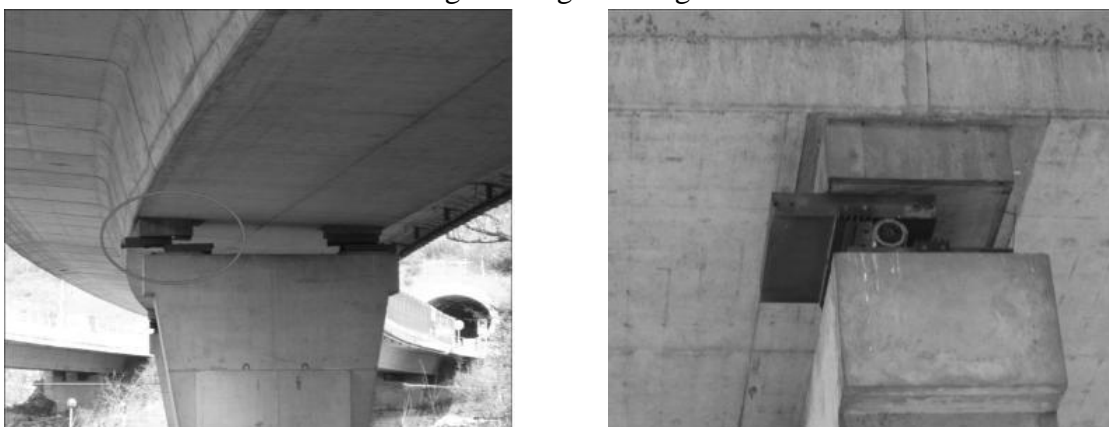
Fig. 10.

Damage to hinge bearing elements

Figures 10 and 11 show some typical cases of bearing failure, the displacement of the bearing hinges, up to complete offset, damage to the trusses, and significant permanent displacements. The latter, in turn, often led to relative displacements and destruction of the expansion joints of the superstructure, as shown in Fig. 12.

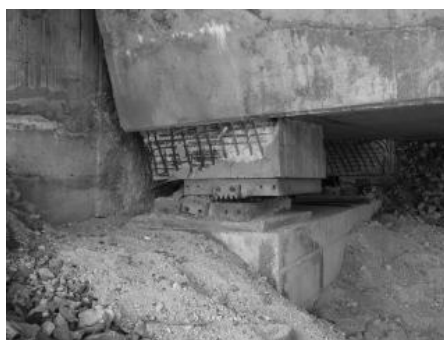
Fig. 11.

Damage to the abutment: offset of the hinge of the bearing part and damage to the abutment stone
