## ENGINEERING ANALYSIS OF STRUCTURES AND ASSESSMENT OF THE TECHNICAL CONDITION OF ARCHITECTURAL MONUMENTS

*This article provides an assessment of the technical condition of the Kok Gumbaz mosque located in the city of Shakhrisabz based on instrumental checks and visual observations. Suggestions and recommendations for the elimination of certain defects, damages and deformations are given.*

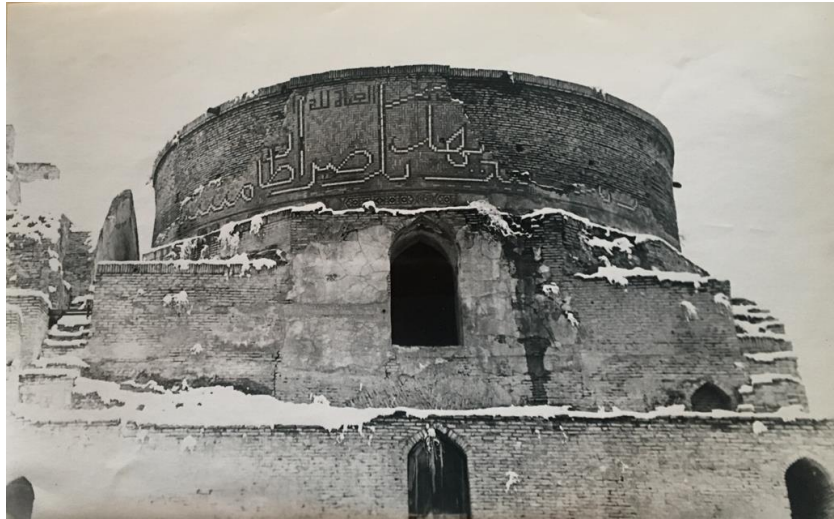
*1 fig.*

*Facade of the northern part of the mosque (1976)*

Judging by archival materials, in ancient times, the side parts of the mosque were destroyed under the influence of earthquakes and due to the fact that the density of soils in the surrounding area was low. In 1993-1994, these parts of the mosque were rebuilt. But the study revealed that the columns were erected on unfinished foundations, soft soils.
